FOLLOW-UP AUDIT OF PINELLAS COUNTY CAPITAL IMPROVEMENT PROGRAM AND INFRASTRUCTURE - UTILITIES

**REPORT NO. 2019-24
AUGUST 21, 2019**

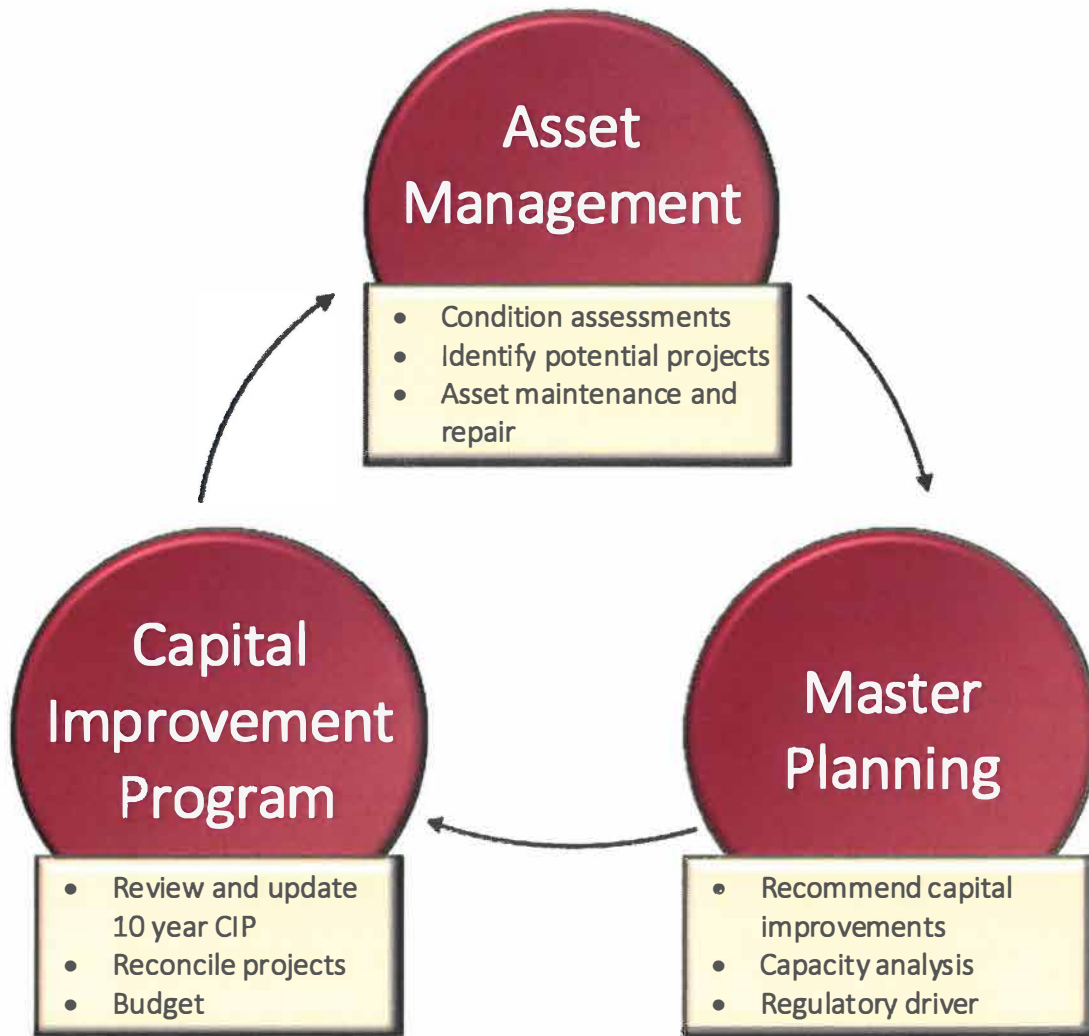
The following diagram demonstrates a proactive process for determining present and future infrastructure needs. Our audit identified opportunities for improvement of the County’s infrastructure planning process.

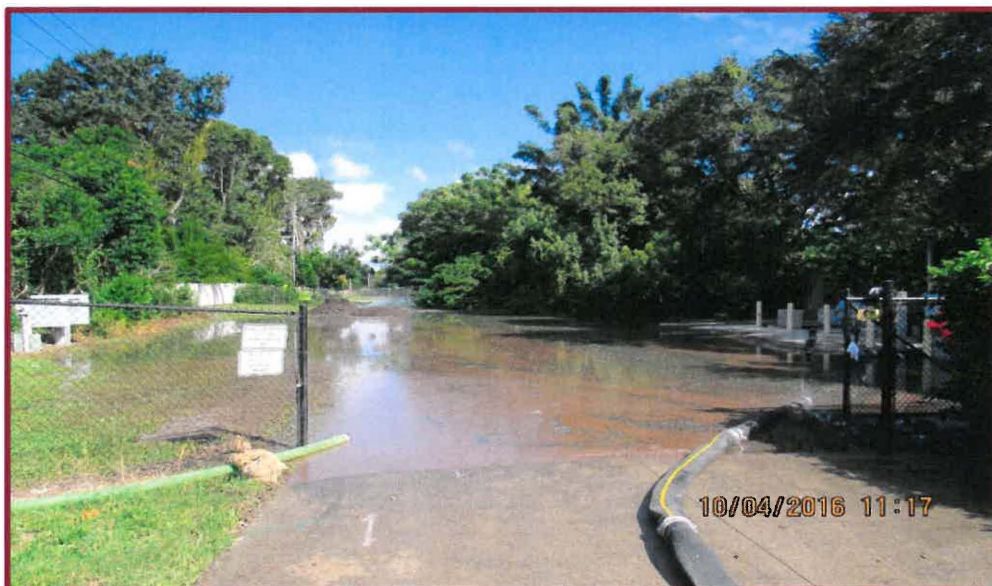
An example of a costly, unplanned failure occurred on October 4, 2016, when a 30-inch sewer line broke in the Palm Harbor area. We toured the area of the break, located on Alderman Road and Omaha Street, on October 4, 2016 at approximately 10:30 am. Utilities and contractor crews were already on-site responding to the issue. We observed that the sewer line break caused

sewage to spill out in the retention pond, almost to the sidewalk by the Utilities pumping station. The smell emerging from the break was very toxic; in addition, there was heavily soiled greenery by the street.

Management stated the break was a result of several factors, which included the age of the pipe, air release valves (ARVs) not opened due to odor issues from years past (it was an administrative decision at that time), as well as the set-up of the pipes that created unnecessary gasses to build up, which eroded the pipes faster than expected.

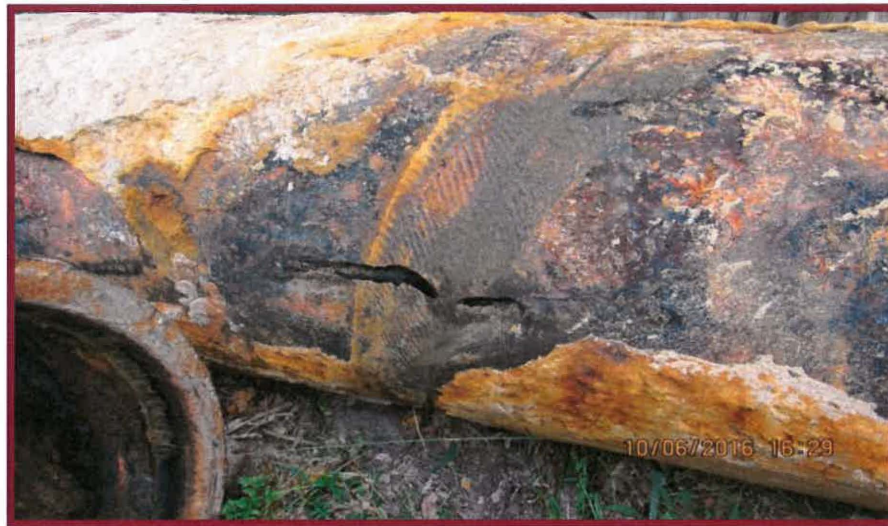
Additionally, in certain parts of the County, at the request of citizens and the discretion of Management, ARVs were closed to eliminate the foul odor from the gases they are intended to release. On October 4, 2016, a 30-inch sewer force main in Palm Harbor broke, spilling an

The picture below demonstrates the level of deterioration of the sewer force main, which caused the Palm Harbor sewage spill.

As a result of this spill, Management stated they will be changing their method of operations regarding ARVs, including not closing them despite the smell and complaints from citizens.

Starting in 2017, Utilities reviewed and reorganized their PM operations and now have a team solely dedicated for sewer ARV maintenance.
